Safety Recall – 2023 CX-50 Trailer Tow Hitch Harness May Detach

REPAIR OUTLINE

This repair is to remove the old Trailer Hitch Harness and install a new updated harness with a different routing than the original factory, dealer or customer installed harness.

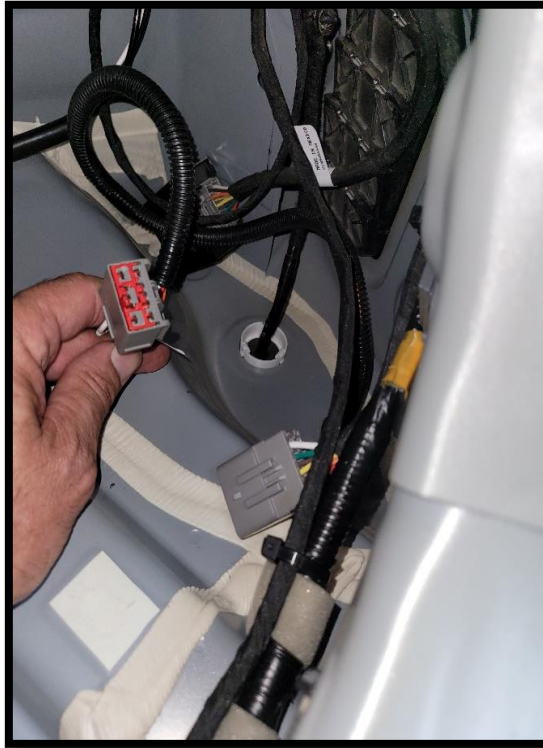
5. Locate the exterior trailer hitch harness and disconnect it.

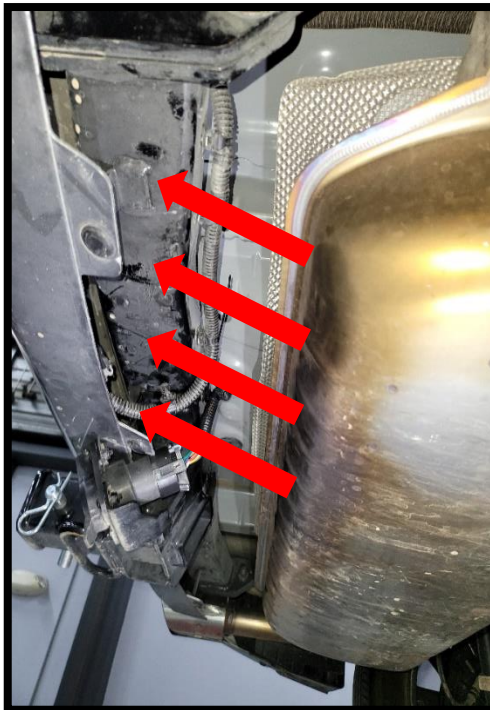
8. Using a fork style panel clip removal tool (2) to remove the harness cable mount clips from tow bar.

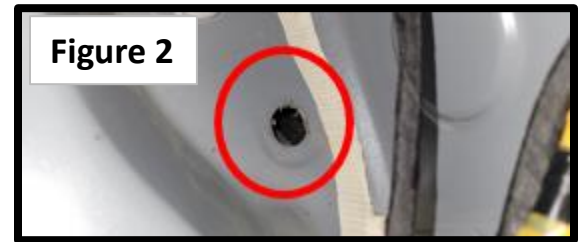
10. Locate the exposed hole where the hitch harness used to go through, under the vehicle near the exhaust.
- Remove any silicone around the hole if present with a plastic scraper tool ③.
 - Using isopropyl alcohol ④ and a shop towel ⑤, thoroughly clean the hole surface area to be covered. Let alcohol dry completely (30 to 60 seconds).
 - Figure 1. Apply body frame tape ⑥ from new harness kit over hole. Press firmly to ensure complete coverage and adhesion. Use 2 pcs if hole is not completely covered.
 - Figure 2. On the inside of the vehicle, apply a silicone-based, anti-corrosion sealer ⑧ to edge of hole from interior side of vehicle.
